**RESEARCH PAPER**

**Challenges and Opportunities for Revitalization of the Architectural Heritage of Saidu Sharif Swat**

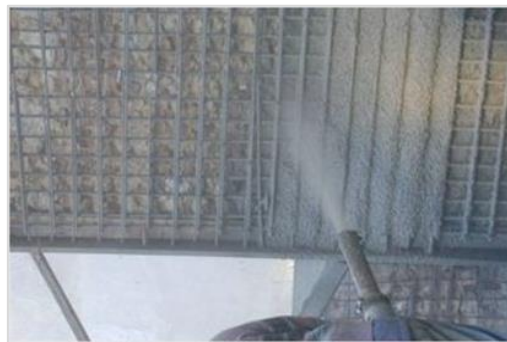
- i) Reinforced cement concrete covering for stone walls in which two layers of RCC are applied, each with two coats, in thin coats in multiple layers on both exterior and interior walls to strengthen the masonry walls up to 4 times their original strength. Plastic mesh and fiberglass can be used and steel connectors are used to connect the existing and the new elements of the wall (Fig 1), so the reinforcement can take place ([Branco & Guerreiro, 2011](#)).

Fig 1: Application of Steel mesh walls & cement grout spraying technique. (Branco & Guerreiro, 2011)

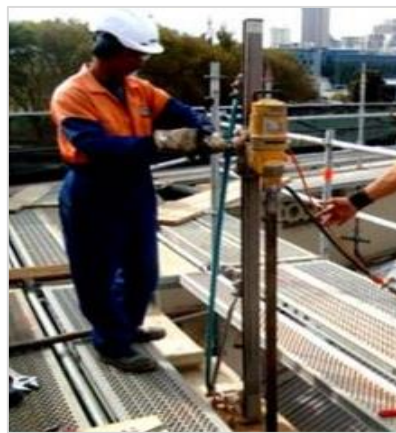
- iii) The technique of retrofitting after tensioning phase in which post-tensioning stretching materials are applied on the center of the wall for post-tensioning modification that strengthens the structure. Initially, the unreinforced masonry is cored on the top up to the foundation (Fig 3) (Branco & Guerreiro, 2011).

Fig 3: Coring Operations and Bar Post-Tensioning (Branco & Guerreiro, 2011)

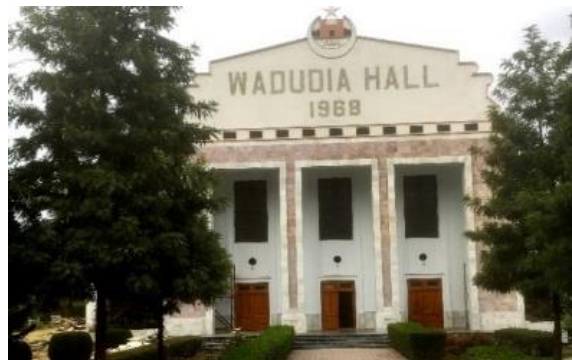
This building was built by the last ruler of Swat in the name of his father, Miangul Abdul Wadud. It was built in 1946 as a ground plus one-story conference hall for the entire region's communities, and it was renovated in 1968. Swat Wadudia Hall was built in 1940 (Figures 8 and 9), and it is currently used as an auditorium for various government events. However, during the recent renovation process, the original Rajistani marble was replaced by local marble (Figure 10), which is against the preservation of the building and has lost its original essence.

Fig 8: South side blocks elevations (Author, 2019)

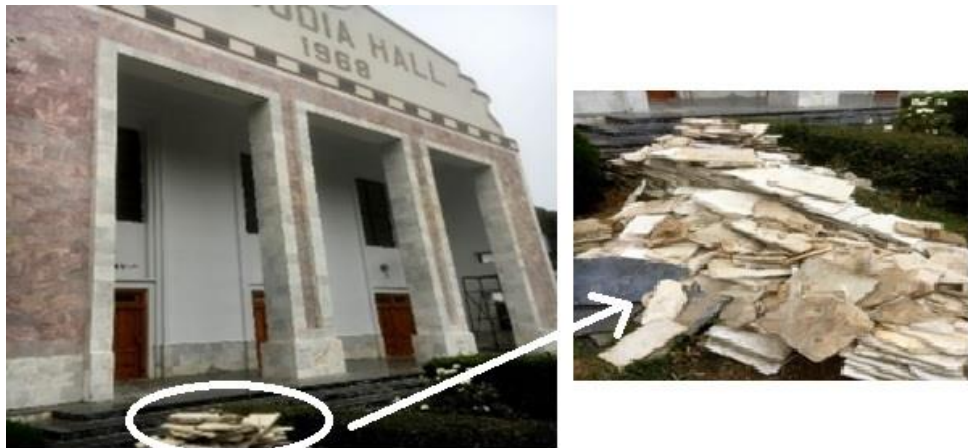
Fig 10: Wadudia hall renovation work in which original tiles were removed (Author, 2019)

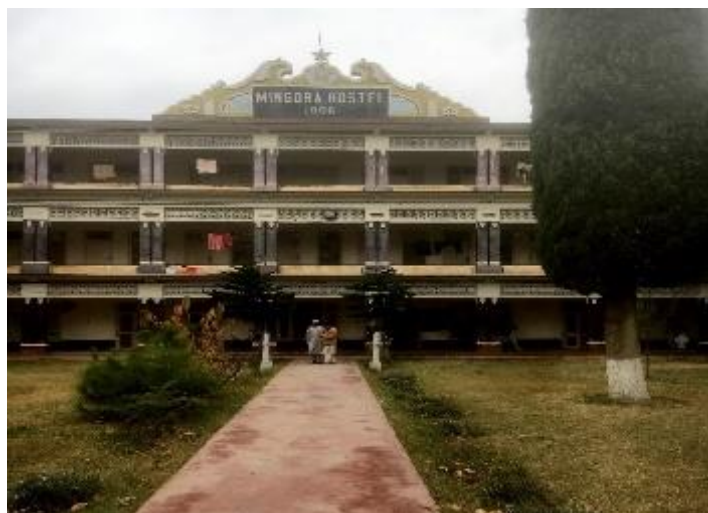
It is a three-story structure with 180 students for the intermediate section (Figure 11). It was built in 1953 and 1956, but later on, from time to time, some renovation work has been done, but it needs serious measures because of damage done by the 2005 earthquake (Figure 12), which requires serious action. In recent years, some commercial development has started that is interfering with the breathing space of buildings (Figure 13), so the whole building including the old structure (Figure 14), needs special attention.

Fig 11: Front façade (Author, 2019)

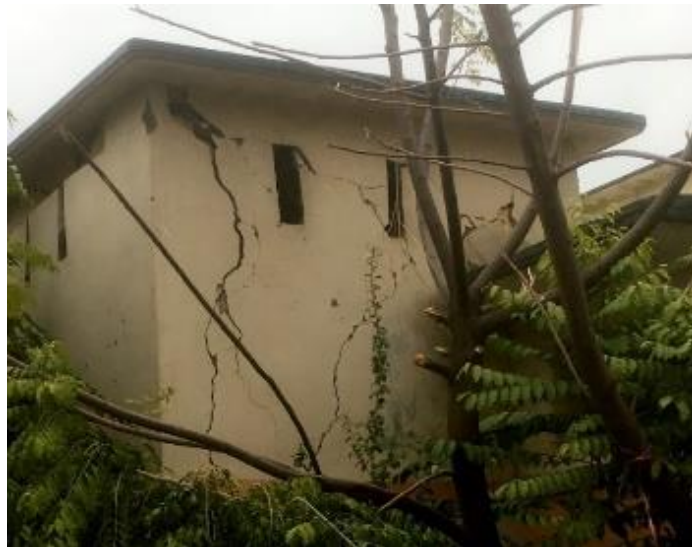
Fig 12: damage by the 2005 earthquake (Author, 2019)

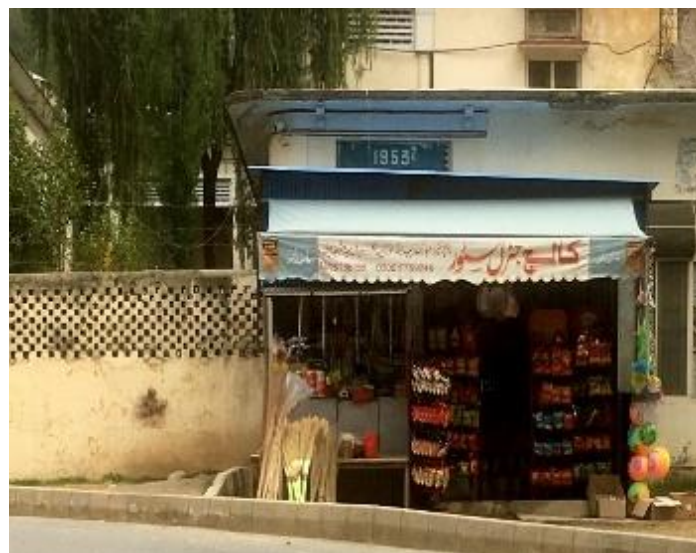
Fig 13: Encroachment (Author, 2019)

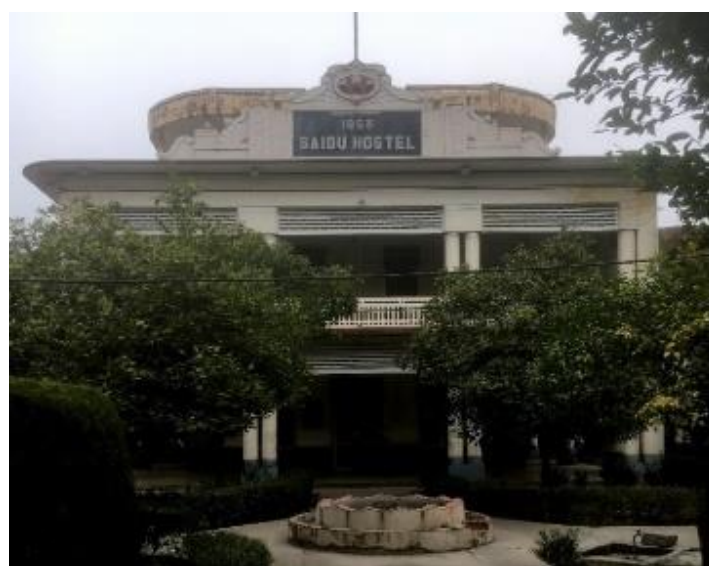
Fig 14: Old building (Author, 2019)

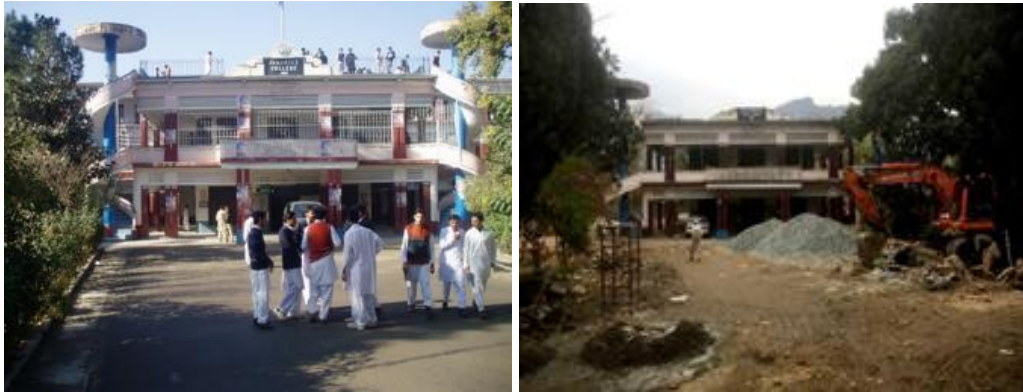
Fig 15: Before and After Demolition for Reconstruction. (swat, 2006) (Author, 2019)

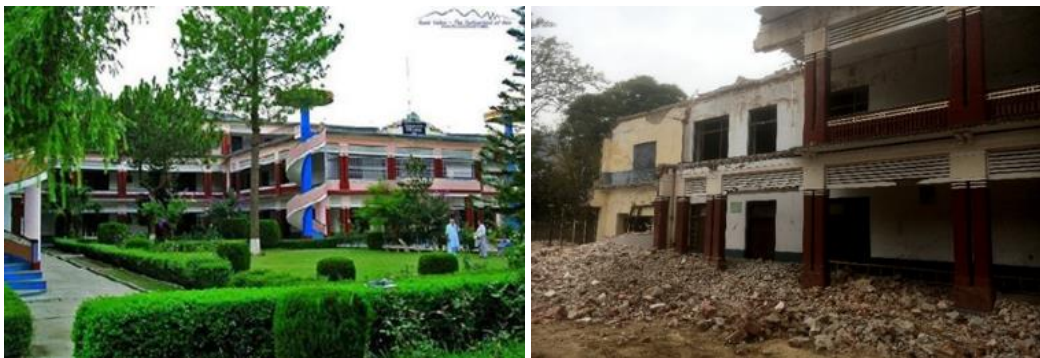
Fig 16: Before and After Demolition of South Block (swat, 2006) (Author, 2019)

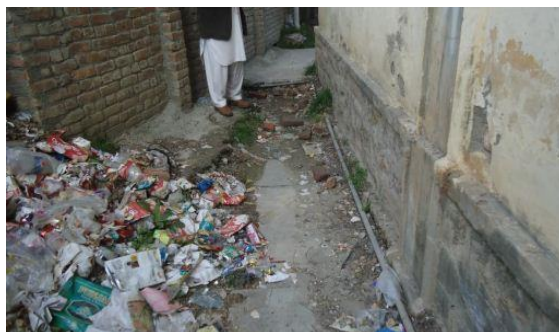
Downpour water channels were found blocked (Figure 17). Standing water in these channels may invade the soil around the foundation (Figure 18). Defrayal in the soil neighboring the structure was likewise seen at the rear of the building, bringing the potential for water close to the structure (DieFiore-1985). A fringe drainage channel is succeeding the main line, which drives into the establishment base (i.e., foundation). This line is operationally great; however, because of certain splits that showed up in the waste line, the entire water is channeled into the base of the college building (DieFiore-1985).

Fig 17: Water channels issues (Author, 2019)

- Long term strategic plan for the city is required to avoid urban sprawl.
- Relevant laws for the protection of heritage sites and buildings are recommended.
- Buildings' distinctive features such as material, size, and scale must be retained as it gives a distinctive character to the historic site of Saidu Sharif whereas construction of new structures that are different from the architectural style of Swat shall not be allowed.
- Sign boards on or attached to heritage buildings shall not be allowed and the existing ones shall be removed.
- Historic buildings facing serious issues of cracking, deflection, or failure must be investigated by concerned professionals.
- The building's original masonry must be retained without the application of waterproof coatings. Repointing of only those areas may be done where moisture exists.

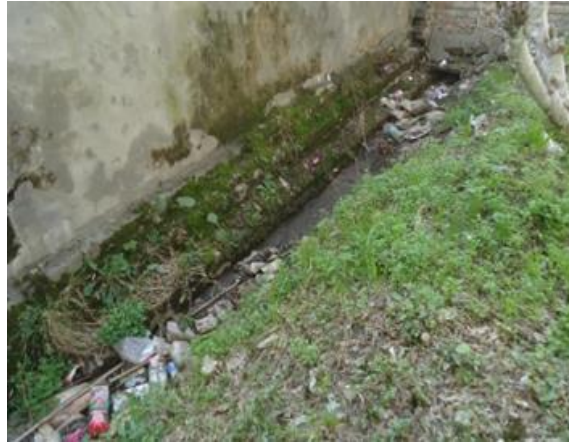
Fig 18: Water channels issues (Author, 2019)

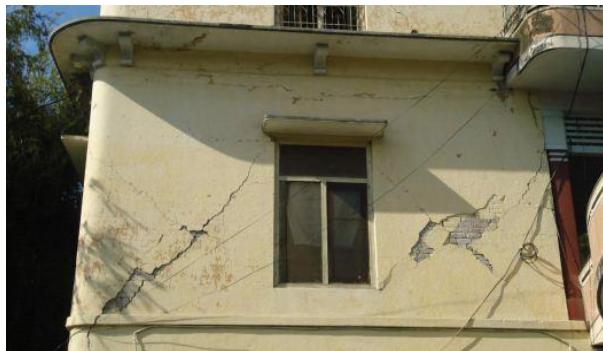
Fig 19: Seismic activity effects (Author, 2019)

Negligible to significant level splits were delivered because of differential settlement and late seismic tremors, which were observed all through the structure in every one of the three stories. These breaks incorporate corner-to-corner shear splits, floor splits, and breaks in supporting segments of stairs (Figures 19 & 20). The northeast and southeast segments of the structure were equally damaged as the center segment of the U-shaped structure. A portion of the breaks was seen as infiltrating the establishment. The breadth of the split was more noteworthy than 0.5 inches in certain areas (Dr. Mohammad Ashraf, 2015).

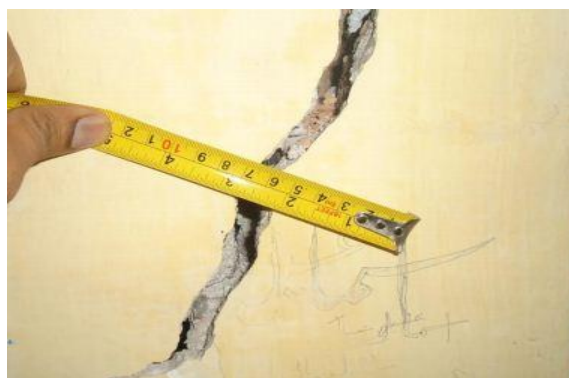
Fig 20: Seismic activity effects (Author, 2019)

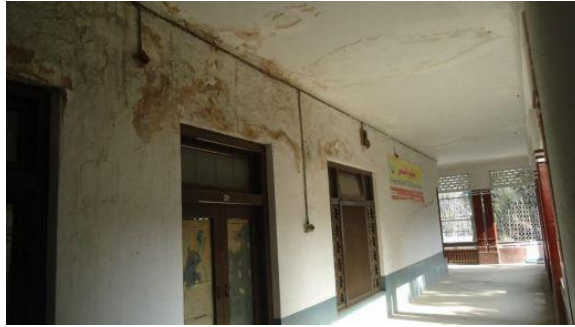
Fig 21: Leakage issues (Author, 2019)

Leakage issues from rooftop and floor pieces were additionally seen in different areas of the structure (Figure 21). As a consequence of this, every one of the constituents and their completions were demolished (Verrall, 1966). Likewise, the constituents become frail, and standard support is needed to make well-being issues connected (Wong and Hui, 2005). As shown in (Figure 22).

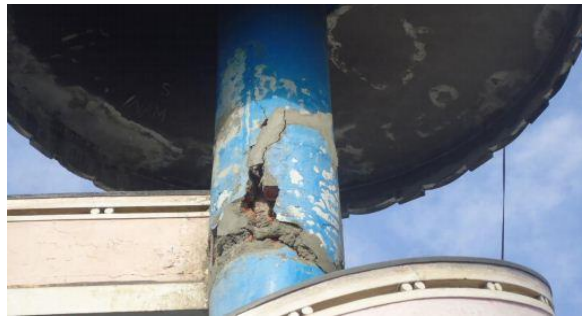
Fig 22: Settlements in pillars (Author, 2019)

Given the building's current state, the October 2015 earthquake triggered lopsided settlements, resulting in structural splits. Authorities were worried about saving the structure and restoring it, yet afterward, they chose to wreck the structure. Jahanzeb College is a significant structure. After Islamia College Peshawar, this school working with an E-shaped structure is the second biggest in the Khyber Pakhtunkhwa area and is a milestone built in 1952 by the last leader of Swat. However, the new structure is completely different from the previous one, and the destroying procedure is currently underway, implying that we have lost another milestone of our legacy in swat.
